**Flood Control Project Maintenance
Levee Inspections**

Maintenance Issue Types Only, Levee Inspection Report By Mile - Spring 2018

Sacramento Maintenance Yard East Levee Yolo Bypass

Waterway	Bank	Unit Miles	Inspection Start/End	Inspector
Unit No. 01 Yolo Bypass	Left	2.01	04/10/2018 04/10/2018	Zach Jojola

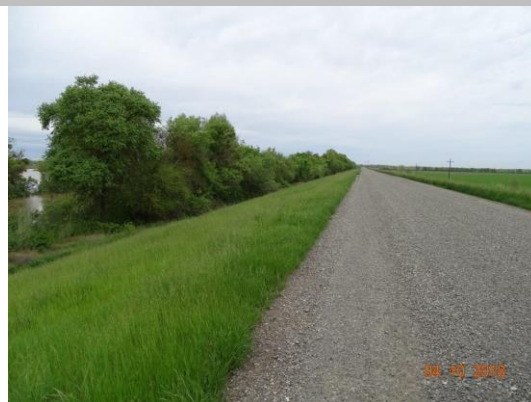
Photo 1 of 1 : SP_2018_ST0004_41_6_20180413_00004.jpg

LM Start	0.07	Rating **	M	Issue No.	6
LM End	2.01	Issue Type +	Ma	Location *	WS
Category	Earthen Levee		GPS Latitude/Longitude		
			Start	End	
Item	Vegetation		38.764333 °	38.736278 °	
			-121.635518 °	-121.633686 °	
DWR ID	DWR_ST0004_01_s_2018_6				
Comment Code					
V1 : Control annual grass and weeds on the levee slopes and easements.					
Inspector Comment

View of vegetation on the waterside slope. Spring 2018.
